8 KENTUCKY STREET/ COSMOPOLITAN HOTEL SITE

Petaluma, California

HISTORIC RESOURCE REPORT

September 2004

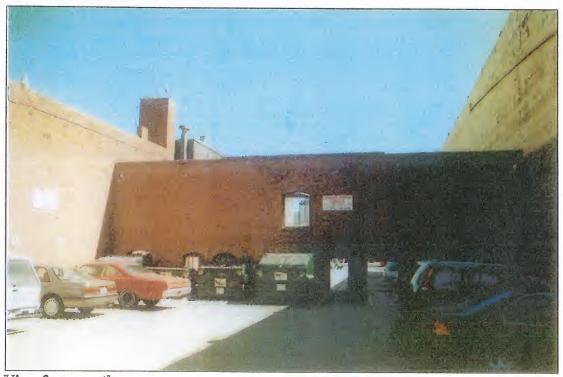
Figure 9: Views of remaining rear wall of Gervasoni Building

The wall remaining at 8 Kentucky Street is essentially the back wall of a structure that was built some time between 1910 and 1919. It is approximately 24 feet high, 12 inches deep at the base, and extends from the McNear Building on the east to the LanMart Building on the west. It is located at approximately the two-thirds point in the lot; in other words, two thirds of the depth of the lot is on the Petaluma Blvd. North side and one third is on the Kentucky Street side (see Figure 2).

The wall is a load-bearing brick masonry wall. There is a narrow brick coping at the top of the wall which steps slightly in the center. There are two door openings and seven window openings, all of which feature a shallow brick arch. The window sash and door jambs are wood. Viewed from the Kentucky Street side, one door is located almost adjacent to the LanMart Building wall, and there is a paired set of what were double-hung windows to its right. Near the center of the wall is another double-hung window of medium width. Above this, at what appears to have been the mezzanine level, is a wider arched opening with narrow vertical metal bars. This appears to have been a fixed window. Flanking the door on the right hand side of the wall are two windows, a narrow double-hung window opening to the left, and a wider window to the right. To the right of

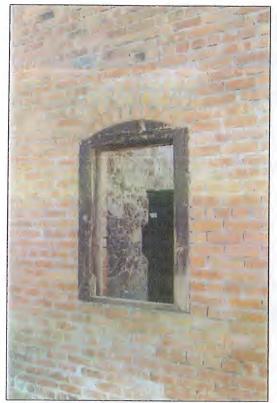
Figure 10: Details of remaining wall from Gervasoni Building

Door detail, west side
